Ohio Department of Transportation

Re: Brifen Cable ISPE, Year 1 Report

ODOT's Office of Roadway Engineering monitored the installation and maintenance on the completed barrier system in an effort to evaluate its performance. This is the first year report.

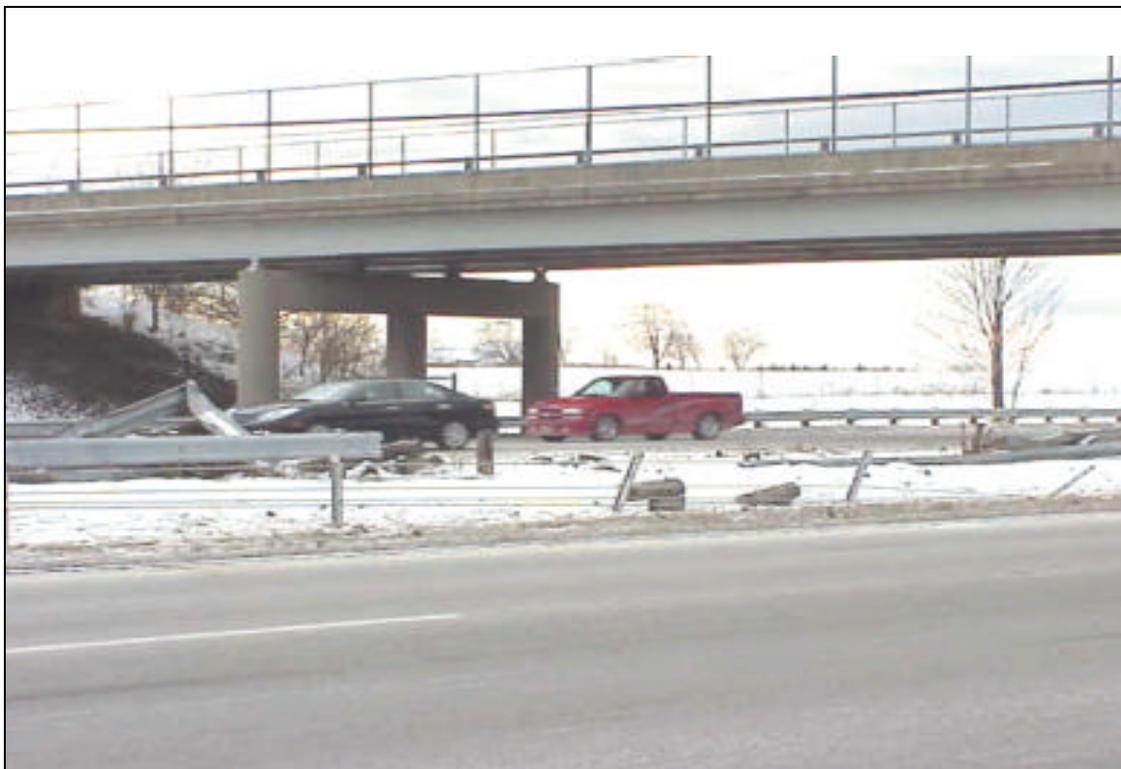
Figure 2: Mack Truck Collision

One key crash that surprisingly did not result in penetration of the cable involved a Mack truck. In this instance a Mack truck penetrated two lines of guardrail but was stopped by the cable rail. Please refer to Figure 2 for a picture of the resulting damage.

According to the OH-1 report, the truck that struck the cable rail in this instance was the Econodyne model produced by Mack in 1998.
