Subject: INFORMATION: In-service Performance Evaluation and Continuous
Monitoring of Roadside Safety Features

SCI GM ATTENUATOR IN-SERVICE EVALUATION REPORT

SCI_GM ATTENUATOR IMPACT HISTORY

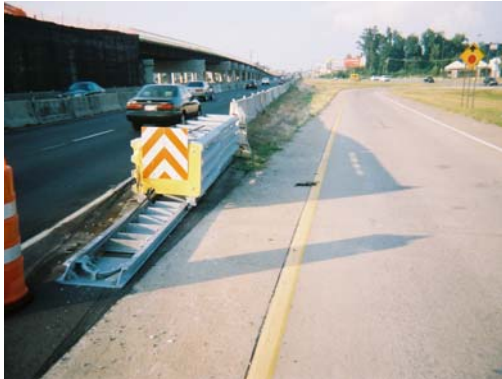
8-7-04 - 1st incident - Serial# 163
Frontal Impact - Collapse 8 feet
No Injuries
Part Required – shear bolts
Repair cost part and labor - \$201.50
Vehicle – not known
Posted speed – 55

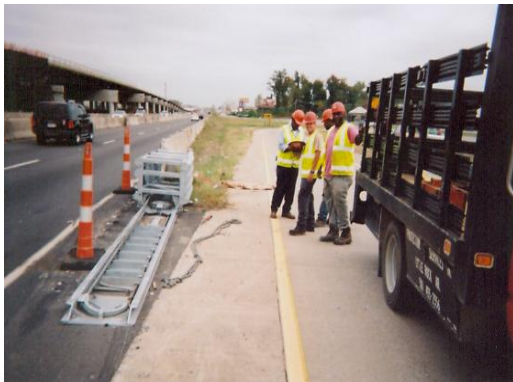
11-2-04 - 3rd Incident – Serial# 163
Frontal Impact - Collapse 14 feet
No Injuries
Part Required – shear bolts
Repair cost part and labor - \$151.50
Vehicle – Tractor/trailer
Posted speed – 55

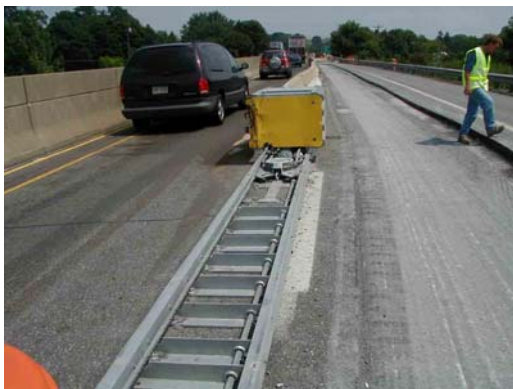
8-16-04 - 1st Incident Serial# 17
Frontal Impact – Collapse - Full
No Injuries
Part Required – shear bolts
Repair cost part and labor - \$201.50
Vehicle – Tractor/trailer
Posted speed – 55

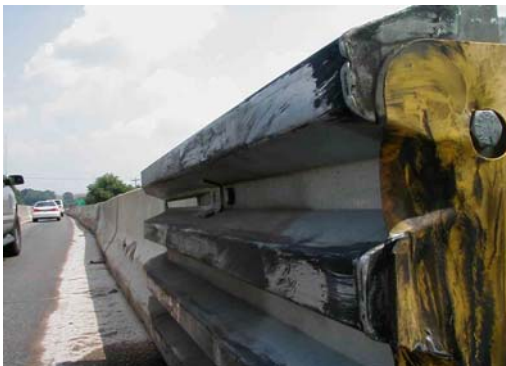
Close up of above incident
When attenuator collapsed, the front wheel of the Tractor/trailer was taken off and the fuel tank was severely damaged. The Tractor/trailer followed down the barrier before coming to a stop. With significant side pressure on the sled, there was no damage to the attenuator except for small dent in top corner which doesn't affect function.

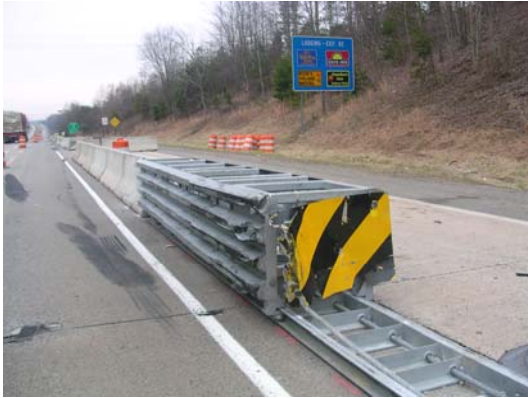
2-8-05 - 2nd Incident – Serial #9
Frontal Impact – Collapse – 6 feet
No Injuries
Part Required – shear bolts and sled panel
Repair cost part and labor - \$426.50
Vehicle – Tractor/trailer
Posted speed – 70

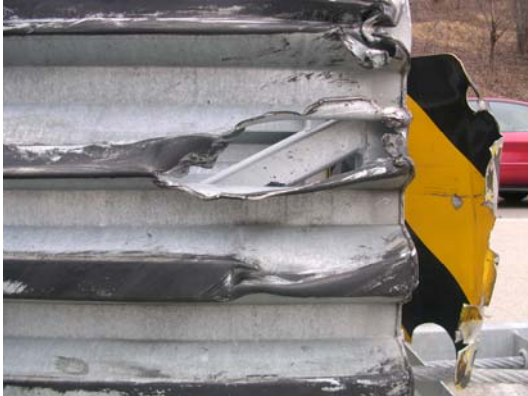
Close up of incident above
This happened one day after the previous incident. It was a glancing blow with something very sharp catching the panels. Even with significant side pressure the sled was not racked and it only required minimal parts.

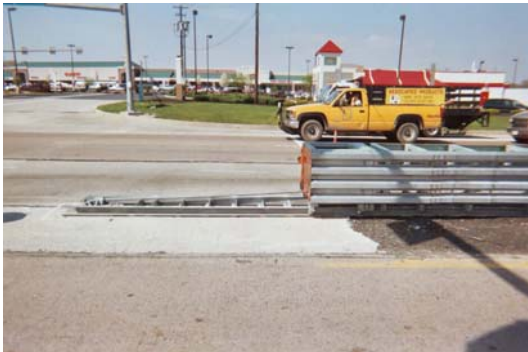
4-20-05 - 6th Incident – Serial #44
Frontal Impact – Collapse – 7 feet
No Injuries
Part Required – shear bolts
Repair cost part and labor - \$101.50
Vehicle – Chevy S10 Blazer
Posted speed – 45

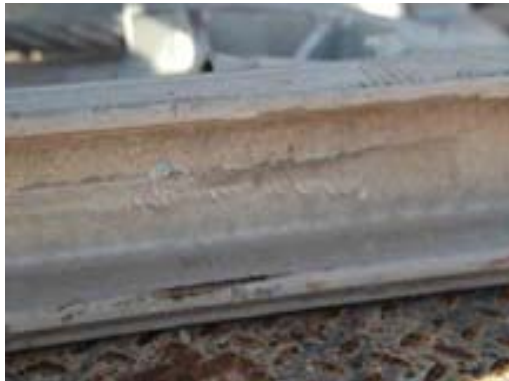
The SCI_GM has machined rollers on its' front sled. These rollers dug into the channel $\frac{3}{16}$ " deep from the side force caused by the lane change.
