Washington State Cable Median Barrier In-Service Study

Submitted for presentation at the 83rd Annual Meeting of the National Transportation Research Board, Washington D.C., 2004.

November 2003

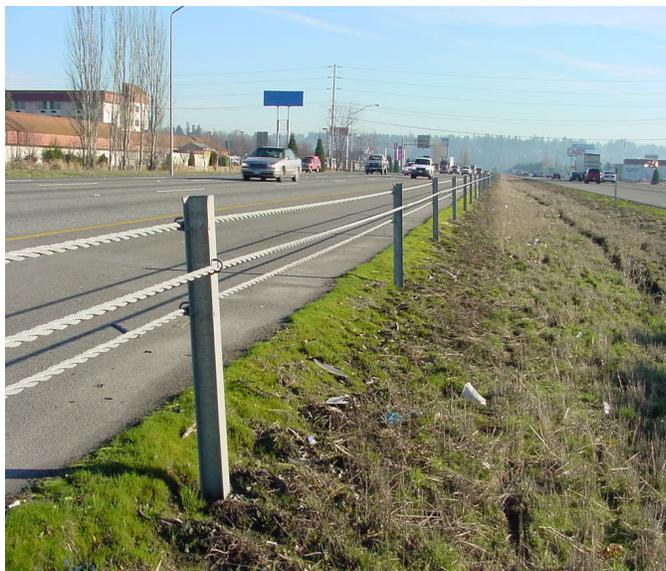
FIGURE 1 Typical cable median barrier installation and details

The Washington State cable median barrier consists of three 3/4 inch diameter cables supported by S3 x 5.7 x 5'-3" long posts. Installation height from the ground surface to the bottom and top cables is 21 inches and 30 inches respectively with the middle cable evenly spaced between them. The middle cable is mounted on the opposite side of the posts. The posts in this system are typically spaced 16 feet on-center (see Figure 1). The system can be placed in the middle of the median or it can be offset. Both systems are used in Washington with the central location chosen where maintenance, grade separation, or slope allows.

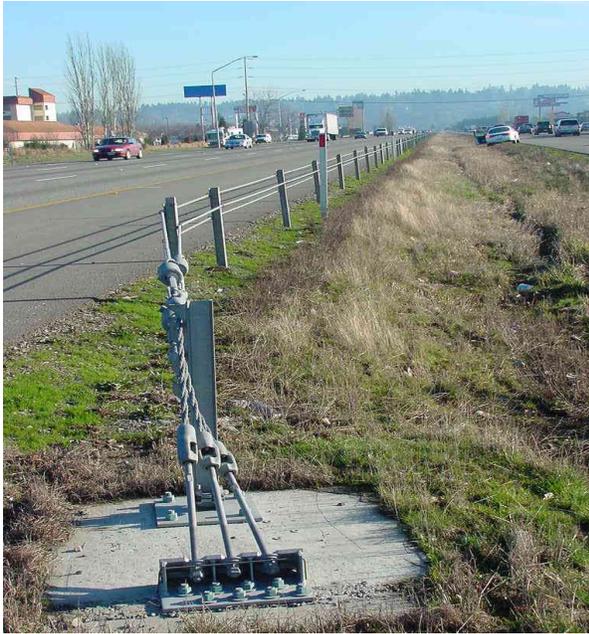
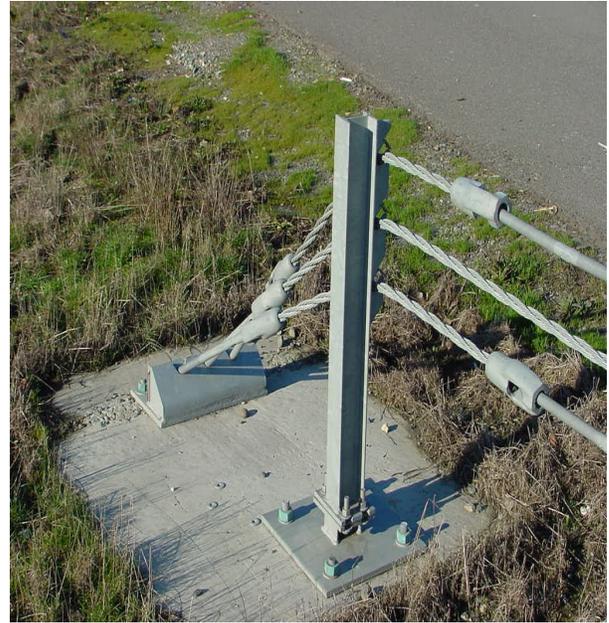
FIGURE 2 Washington State cable barrier terminal

The terminal designs used by WSDOT for cable barriers are nearly identical to the terminals approved by the FHWA (7). The ends of the cables are attached to turnbuckle assemblies that are bolted to a breakaway anchor angle and anchored rigidly to a concrete footing (see Figure 2). Spring cable end assemblies are installed on the ends of the cables and the barrier runs are limited to 2000' between the terminals. Compressing the springs introduces tension in the cables, and thus they are designed to compensate for temperature variations. The WSDOT has also developed a transition to W-beam guardrail, based on South Dakota's design (see Figure 3).
